**BRUCE CASTLE OAK
TOTTENHAM
LONDON**

**Condition, Landscape Assessment and
Management Recommendations**

**Prepared at the request of
Woodland Trust**

**By
Luke Steer BSc.(Hons) Dip.Arb.(RFS) F.Arbor.A. MICFor.**

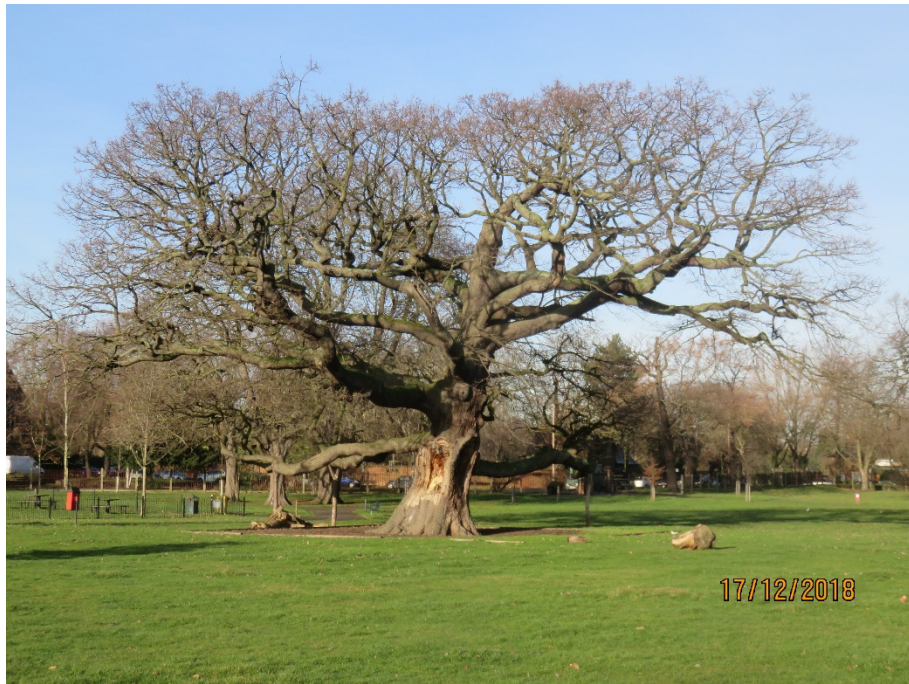
Photograph 3

Bruce Castle Oak from the south-east. Two large branch wounds can be seen in its trunk.

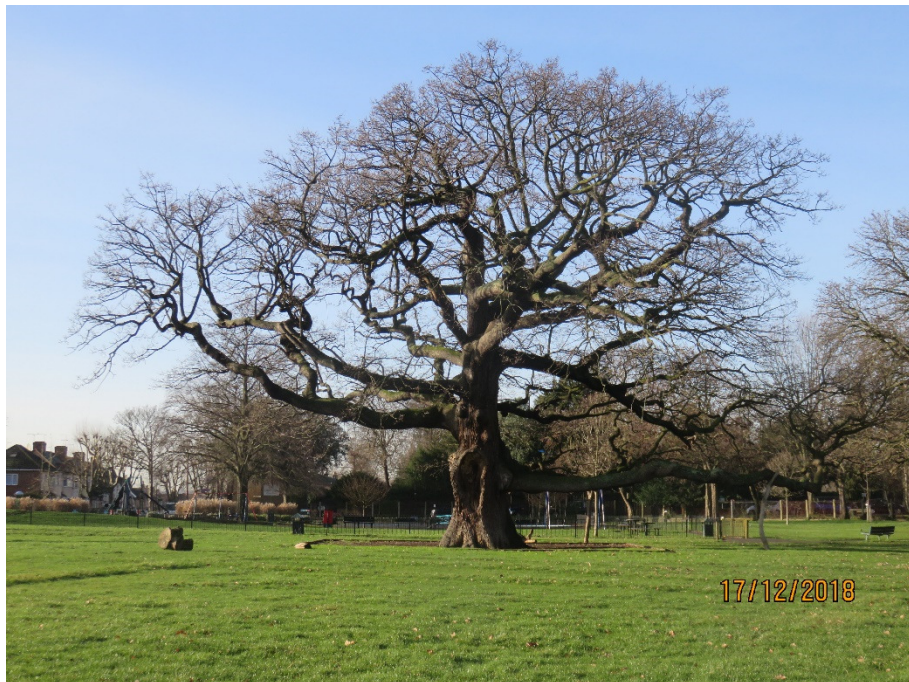
Photograph 4

Bruce Castle Oak from the east. A large branch wound is visible in its trunk and the low branch to the right has been propped.

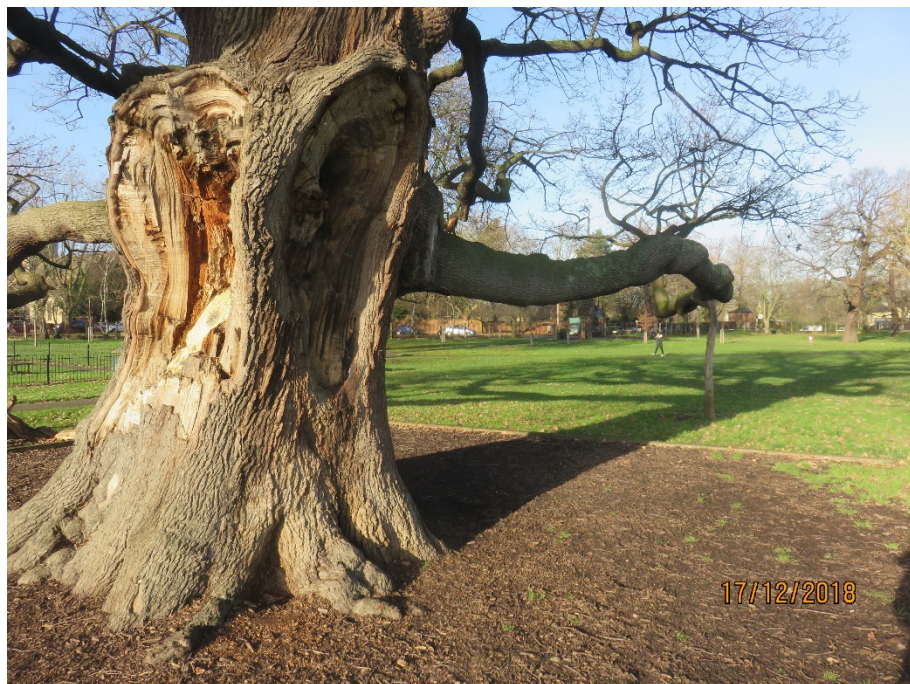
- There is a major branch wound in the trunk on the south between 0.9m and 3.3m above the ground (see Photograph 6). I understand that the branch failed around eight years ago. There is brown rot, potentially caused by sulphur fungus (*Laetiporus sulphureus*) and the cavity has been filled with mortar and logs to reduce the risk of fires being started in it. This wound is up to around 1.25m wide and there is dead bark below it.
Significance – Moderate

- There is a branch wound in the trunk on the east between 1.4m and 3.5m above the ground (see Photograph 6). This wound is around 75cm wide and I understand that the branch failed around 28 years ago. There are fungal remains in the wound, potentially of sulphur fungus (*Laetiporus sulphureus*). There are small black tar-like exudations.
Significance – Moderate

Photograph 6
The trunk of Bruce Castle Oak from the east. The two large branch wounds are decaying and wound-wood is forming around their margins. The left-hand wound was created around eight years ago and the right-hand one around 28 years ago. The low branch to the right is growing to the north and is propped 9.4m from its union with the trunk.

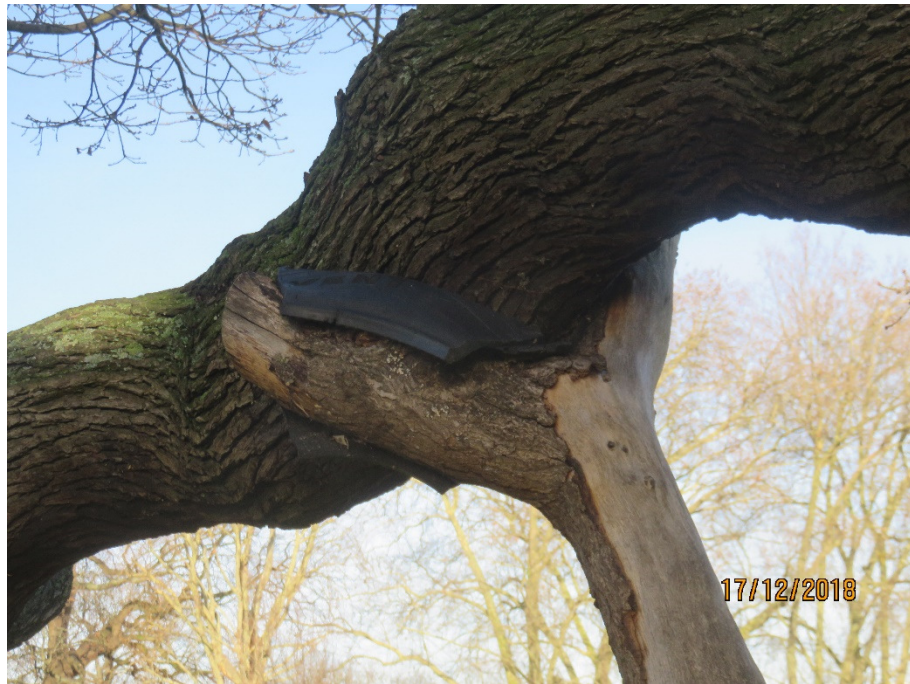
Photograph 7

The props do not appear decayed at present. Over time I expect the props will decay and become increasingly fragile. At some point they will have to be replaced.

The prop supporting the low branch to the north. The prop is 9.4m from the branch union with the trunk of the tree. Parts of a tyre have been used to cushion the branch.

When it is judged that the props should be replaced, I suggest that a suitable engineer should be instructed to work with an arboriculturist to ensure that the props will provide necessary support without killing patches of bark where they touch the tree. MacLeod and Cram (1996) suggest that trees can exert around 800kPa. I suggest that pressures above this may prevent growth and eventually lead to bark death. I recommend that props should be designed to exert much less than 800kPa to the branches they are supporting.

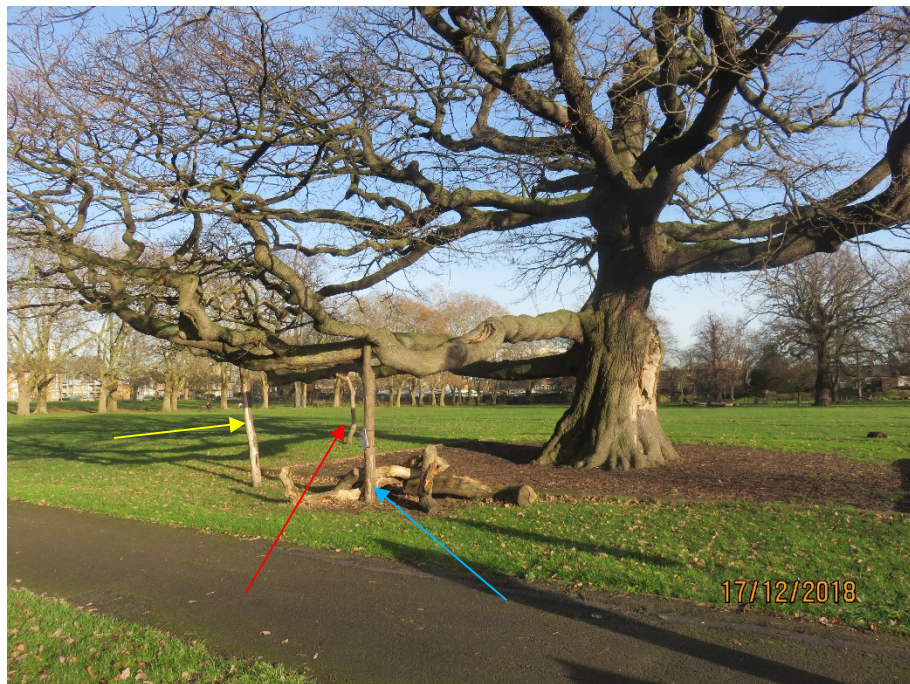
Photograph 8

Props supporting the branches. The red arrow is pointing to the prop supporting the low branch growing to the north. The blue arrow is pointing to the prop supporting the southern secondary branch of the branch growing to the west, north-west. The yellow arrow is pointing to the prop supporting the northern part of the secondary branch of the branch growing to the west, north-west.

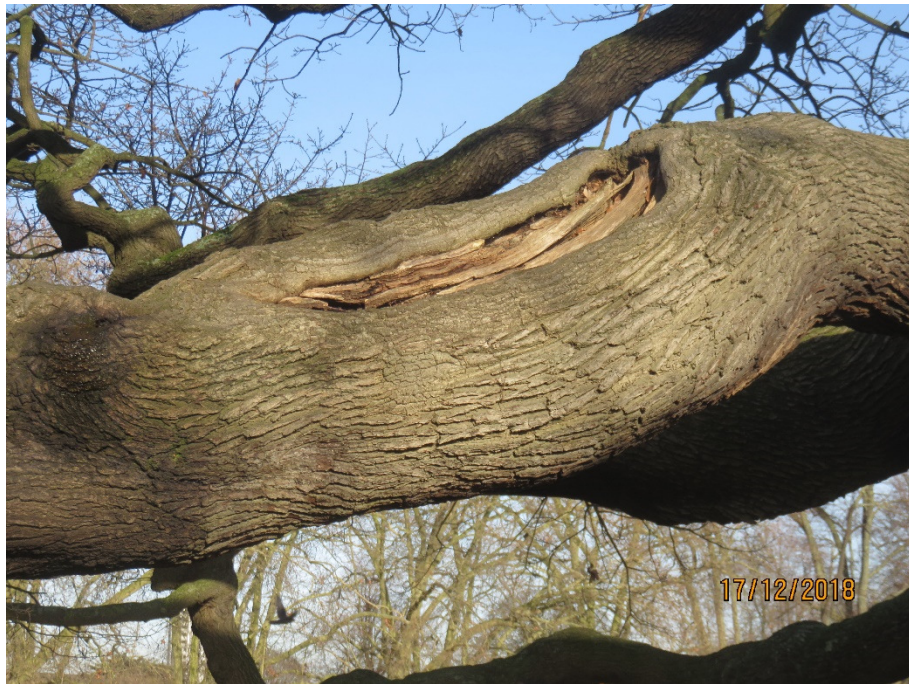
Photograph 9

There is a decaying wound on the upper-side of this branch from 4.6m to 5.7m from its union with the trunk (see Photograph 9). This wound holds water.

A decaying and occluding wound on the upper-side of the propped low branch growing to the west, north-west.

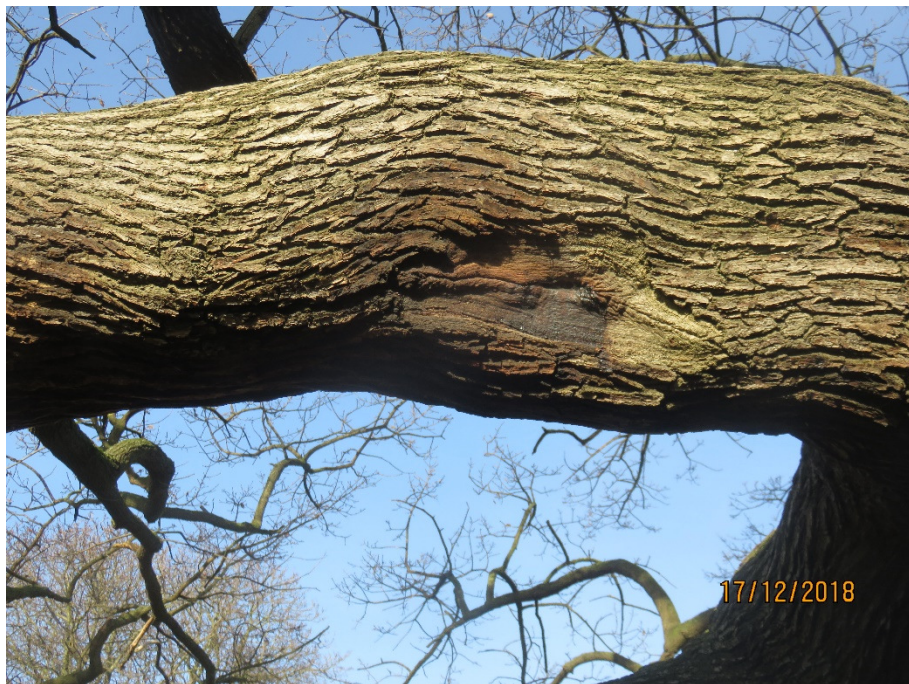
Photograph 10

Exudations from an occluded wound in the branch growing to the west, north-west. Decay associated with this wound may be the same as that in the cavity shown in Photograph 9.

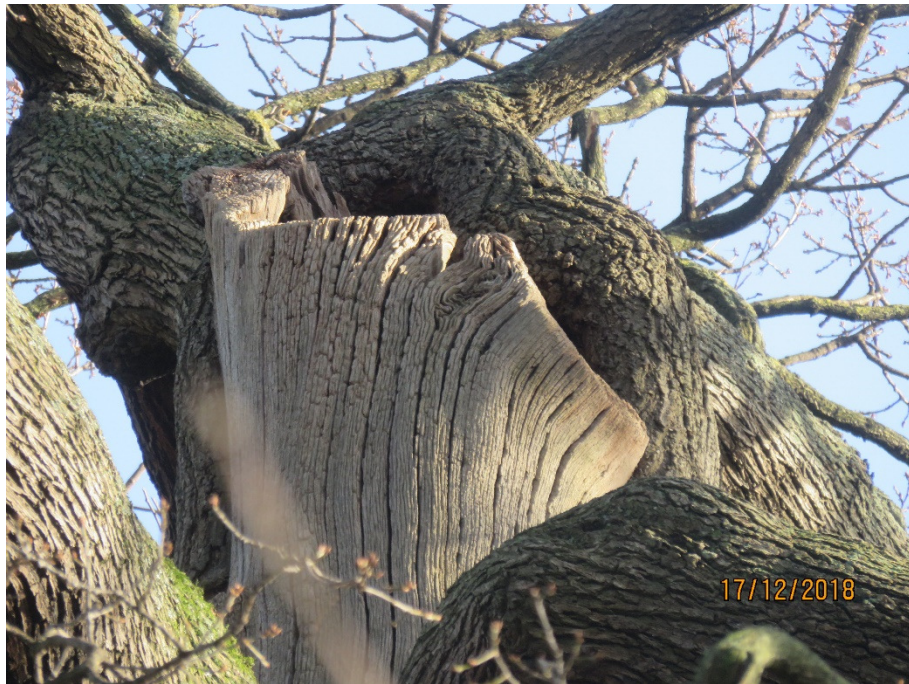
Photograph 11
Old, decaying pruning wounds.

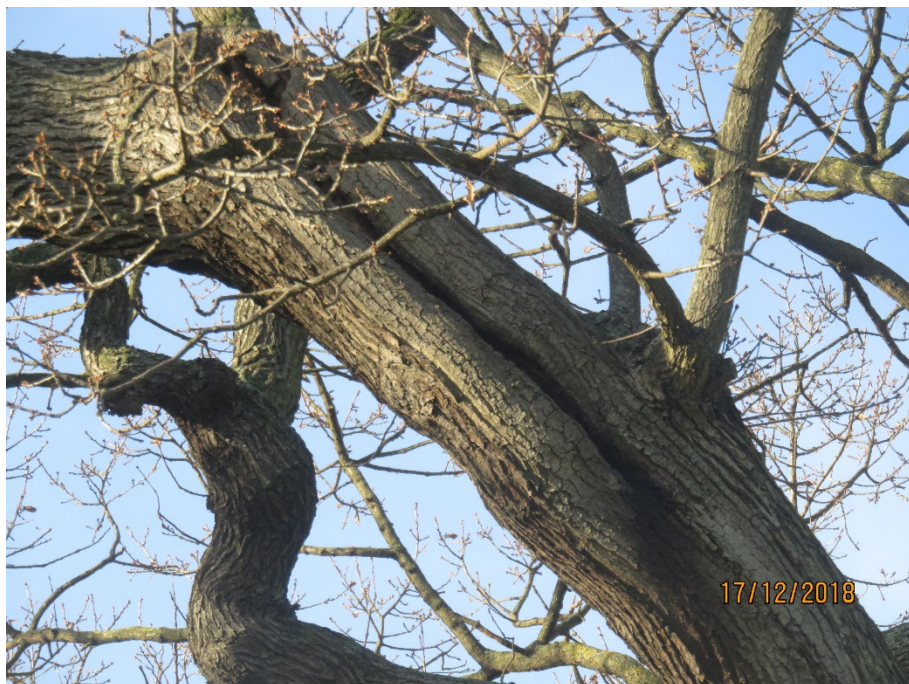
Photograph 12
An old decaying elongated cavity. Bats could potentially roost in this cavity. The cavity may have resulted from a pruning wound initiating dysfunctional bark and sapwood below it, especially if the health of the tree was compromised.

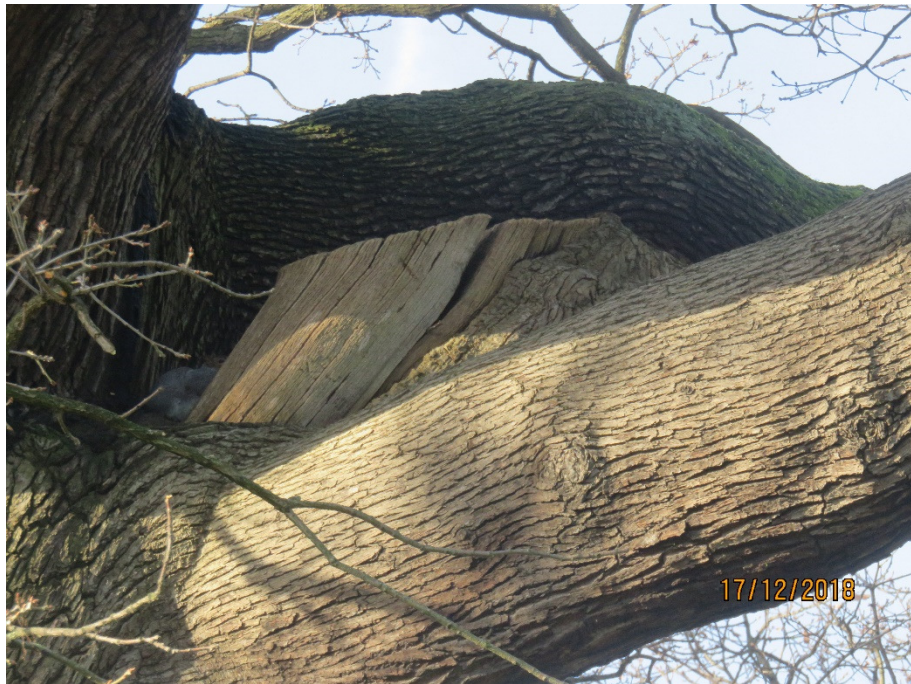
Photograph 13
An old decaying pruning wound.

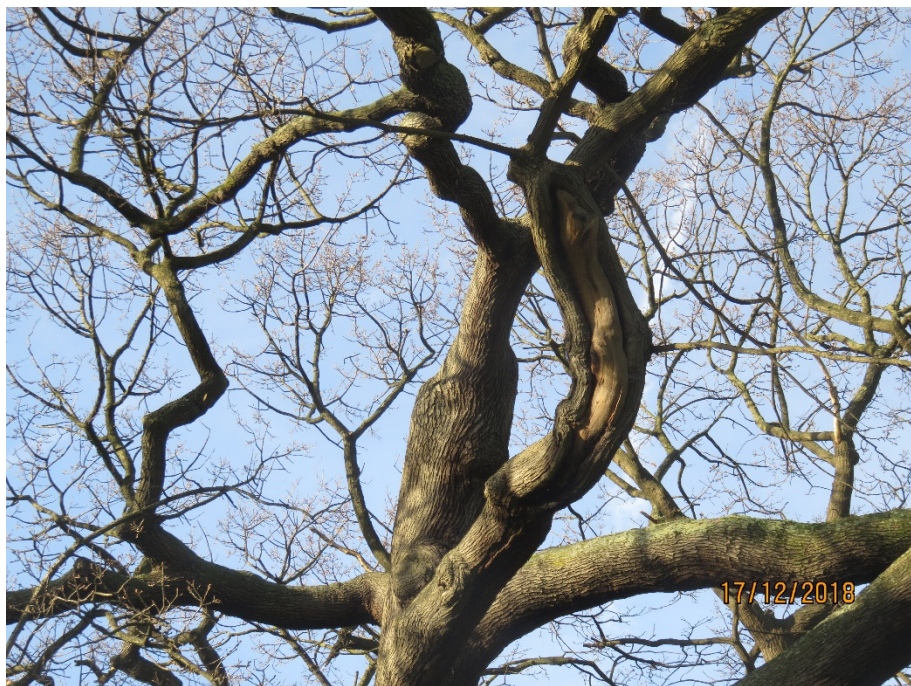
Photograph 14
An old pruning wound and occluding dysfunctional area below its base.

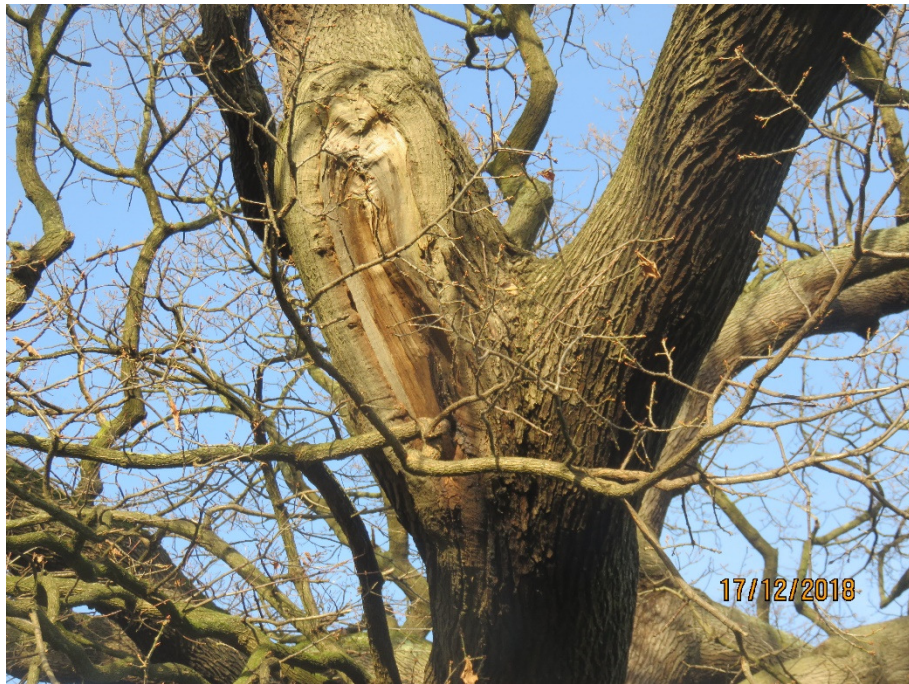
Photograph 15

- A branch has failed around 5.5m from the trunk of the tree on the south at an acute union (see Photograph 15). The wound is up to around 30cm wide and 1m long and is occluding.
Significance – Minor

An occluding branch failure wound. This occluding wound is around 5.5m from the trunk on the south. It appears to be the result of the failure of an acute union.

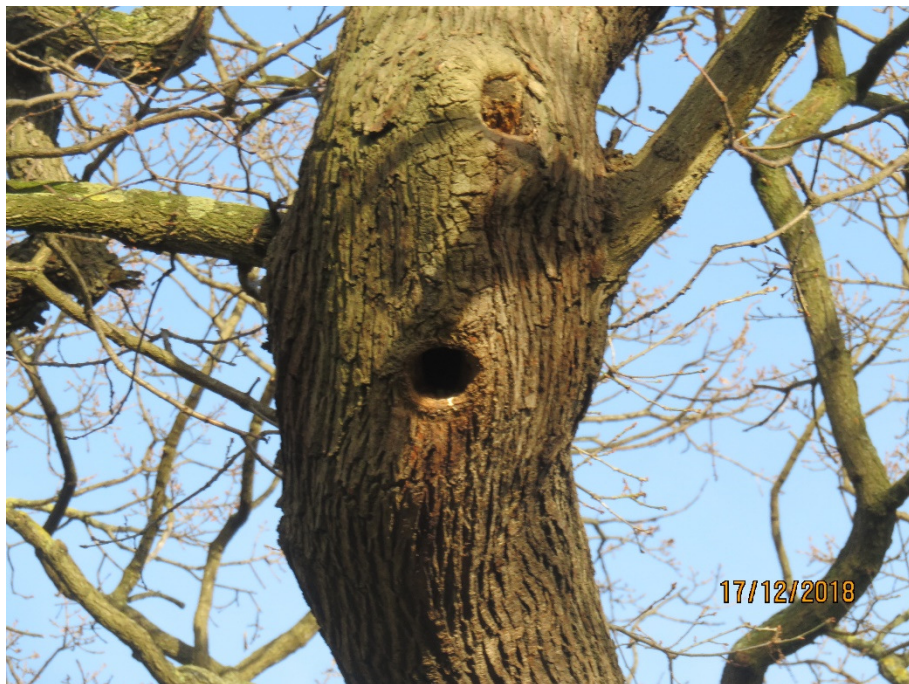
Photograph 16

- There is a woodpecker hole in a branch to the south, south-west around 6.8m from the trunk (see Photograph 16). This indicates that the branch contains decay. This is below a branch wound at an area that appears to be swollen.

A woodpecker hole in a branch on the south, south-west of the tree below an old pruning wound. This indicates that there is internal decay.

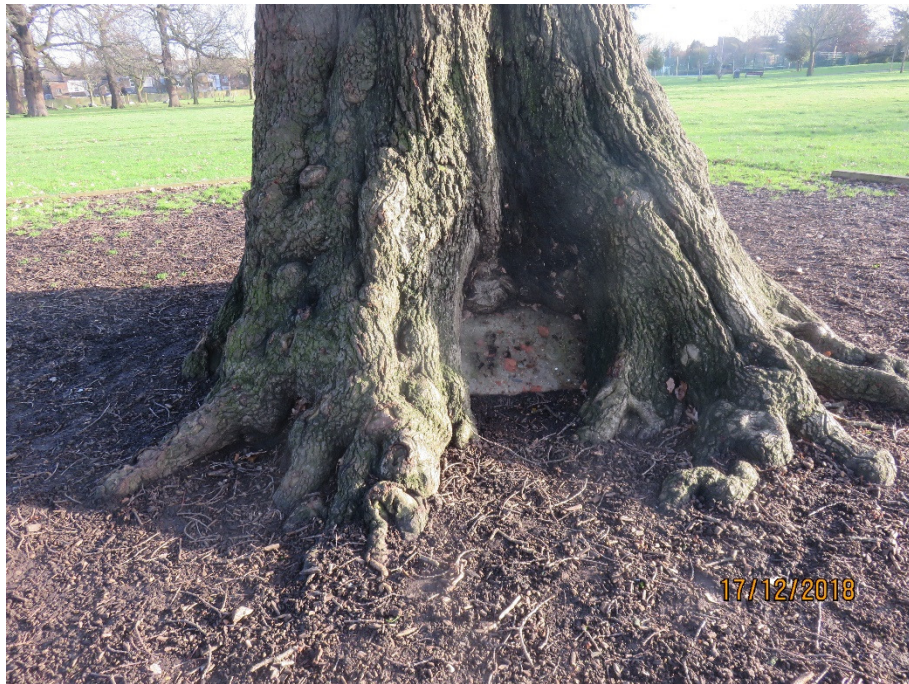
Photograph 17

Concrete between pronounced buttresses at the base of the tree. This may be filling a decaying cavity.
