**BRUCE CASTLE OAK
TOTTENHAM
LONDON**

**Condition, Landscape Assessment and
Management Recommendations**

**Prepared at the request of
Woodland Trust**

**By
Luke Steer BSc.(Hons) Dip.Arb.(RFS) F.Arbor.A. MICFor.**

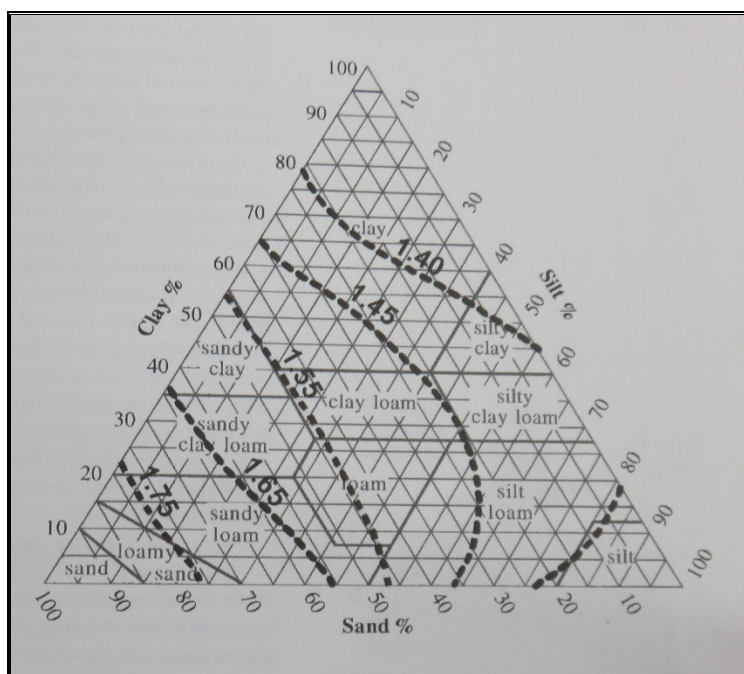
Results from the soil analysis will guide soil management. Figure 1 shows root growth limiting bulk density contours for different soil textures. If the soil is compacted to near these densities work may be required to de-compact it.

Figure 1
Soil texture triangle chart with contours showing root growth limiting bulk densities (gm/ml or mg/m³). (Urban, 2008)

Soil remediation can potentially harm tree roots and symbiotic mycorrhizal fungi. Soil remediation should only be undertaken if assumed benefits to the tree outweigh the problems. Soil remediation should be based on advice from suitably knowledgeable arboriculturists and soil scientists.

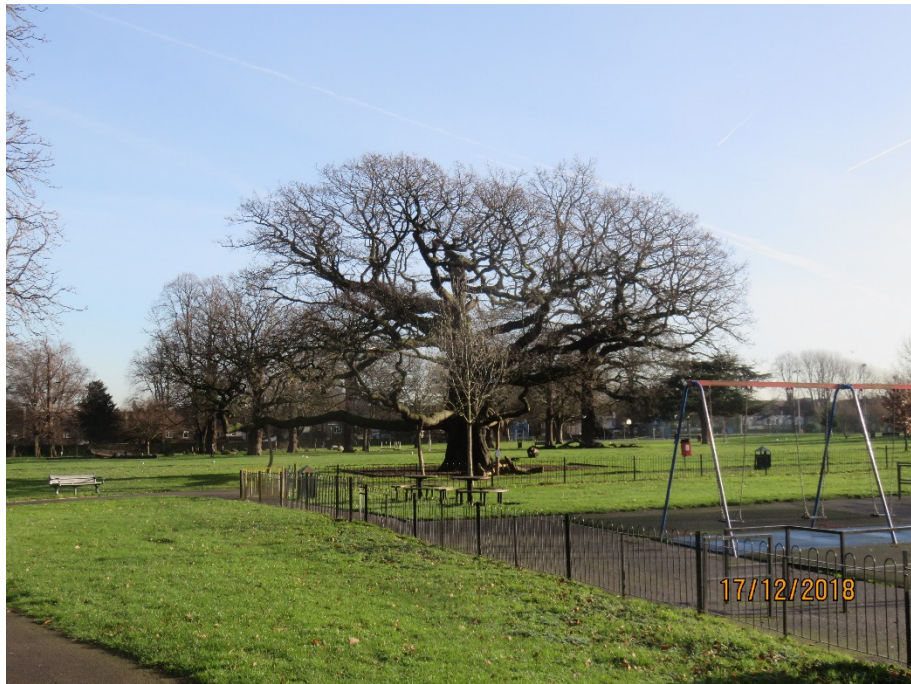
Photograph 1
Bruce Castle Oak from the west, north-west.

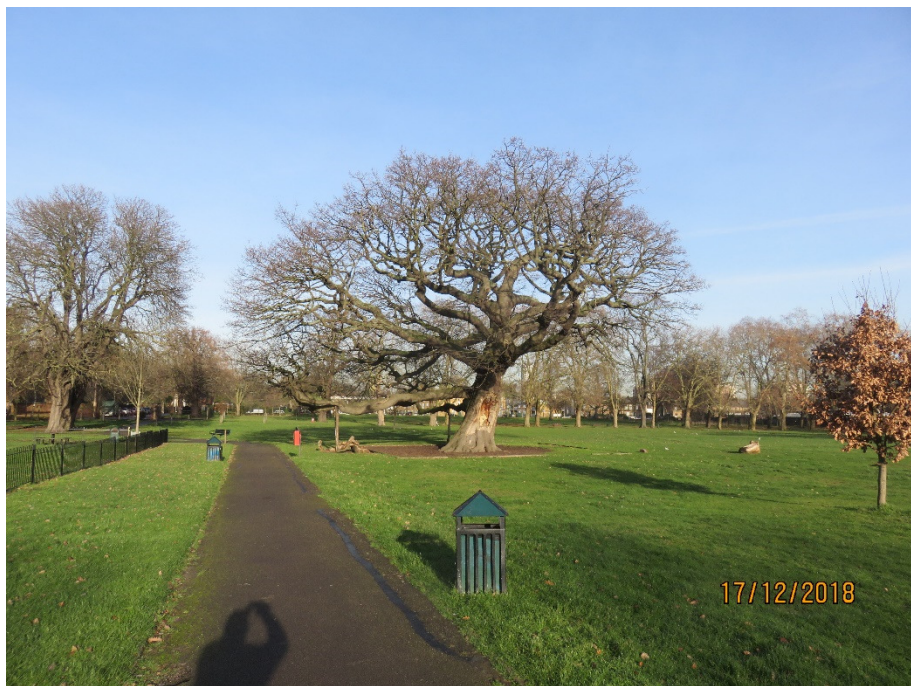
- There are worm casts on the soil near to the tree. Worm activity is considered beneficial.
- The tree is standing in a mulched square (see Photographs 2 and 6). The distance between the base of the tree and the edges are:
 - northern edge – 6.15m;
 - eastern edge – 6.3m;
 - southern edge – 6.4m; and
 - western edge – 6.15m.
- There is a tarmac path 10m to the west of the tree (see Photograph 2).
- There is a semi-mature ash tree 19.6m to the west of Bruce Castle Oak. The gap between the canopies of the two trees is around 3m.
- There is a semi-mature oak 27.1m to the south of Bruce Castle Oak. The gap between the canopies of the two trees is around 10m.
- There is a woodpecker hole in a branch to the south, south-west around 6.8m from the trunk (see Photograph 16). This indicates that the branch contains decay.

Photograph 2
Bruce Castle Oak from the south.

Currently there is an area around the tree mulched with wood-chips that is roughly 12m square. I consider it likely that expanding this will cause an improvement in the soil for tree roots. This will be confirmed by the soil assessment. If the soil assessment confirms that it would be beneficial to extend the mulched area, I suggest extending it to 2m outside the canopy of the tree should be considered.

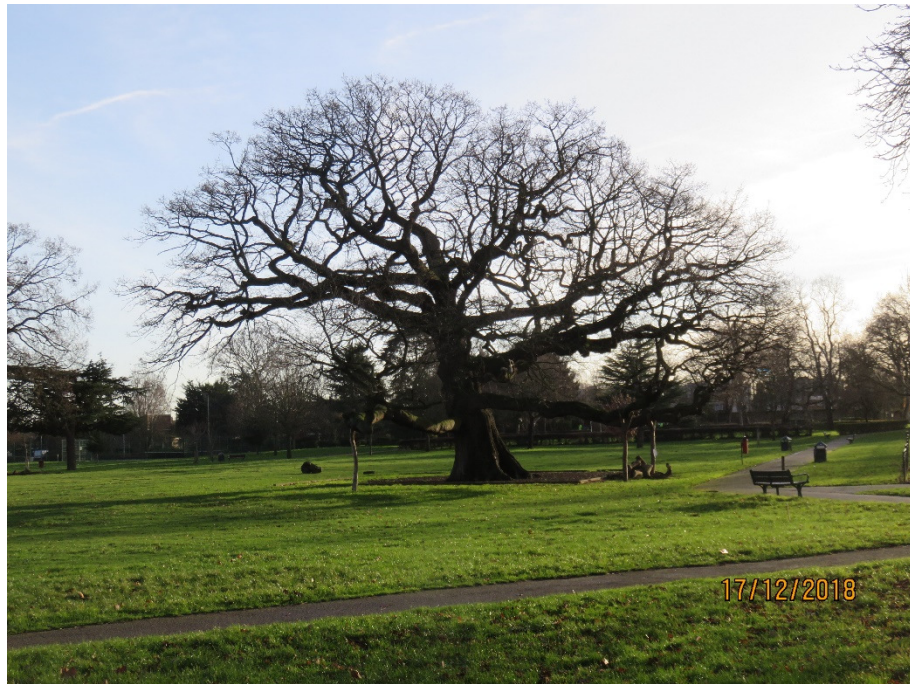
- Leaves lying on the ground near Bruce Castle Oak indicate that it is a sessile oak (*Quercus petraea*).
- I assessed the tree to be in the 'Ancient' age class (see Appendix 2).
- Using a Truepulse laser rangefinder I measured the height of the tree to be 16.5m.
- The trunk diameter is 207.5cm at its narrowest point, which is at an angle between heights of 1.2m to 1.7m above ground level.
- I assessed the tree to be in the 'Moderate Vitality' health class (see Appendix 2).
- Two of the branches have been propped and one of these is propped in two places.
 - The long lower branch to the north (see Photographs 5, 6, 7 and 8)

This branch is propped 9.4m from the trunk. This branch is 16.2m long. Good annual twig extension and few dead twigs. This branch has been reduced and there are some pruning wounds with diameters up to around 10cm. There are also some older, occluding branch wounds. There are no epicormic shoots on the main part of this branch. The wooden prop is up to around 19.4cm in diameter. I do not know what species of tree it came from, but it may be oak. There is part of a tyre protecting the branch where it is propped.
 - Branch growing to the west, north-west (see Photographs 5 and 8)

Photograph 5
Bruce Castle Oak from the north, north-west.
